<p>CARLO GAVAZZI</p> <p>CARLO GAVAZZI SPACE SpA</p>	<h1>AMS02-TCS</h1>	<p>DOC N°: AMSTCS-RP-CGS-007</p> <p>ISSUE : 1 DATE: 17.10.2008</p> <p>PAGE : 1 of 21</p>
--	--------------------	---

INSPECTION REPORT

WAKE RADIATOR 22-AMS-000.00.00

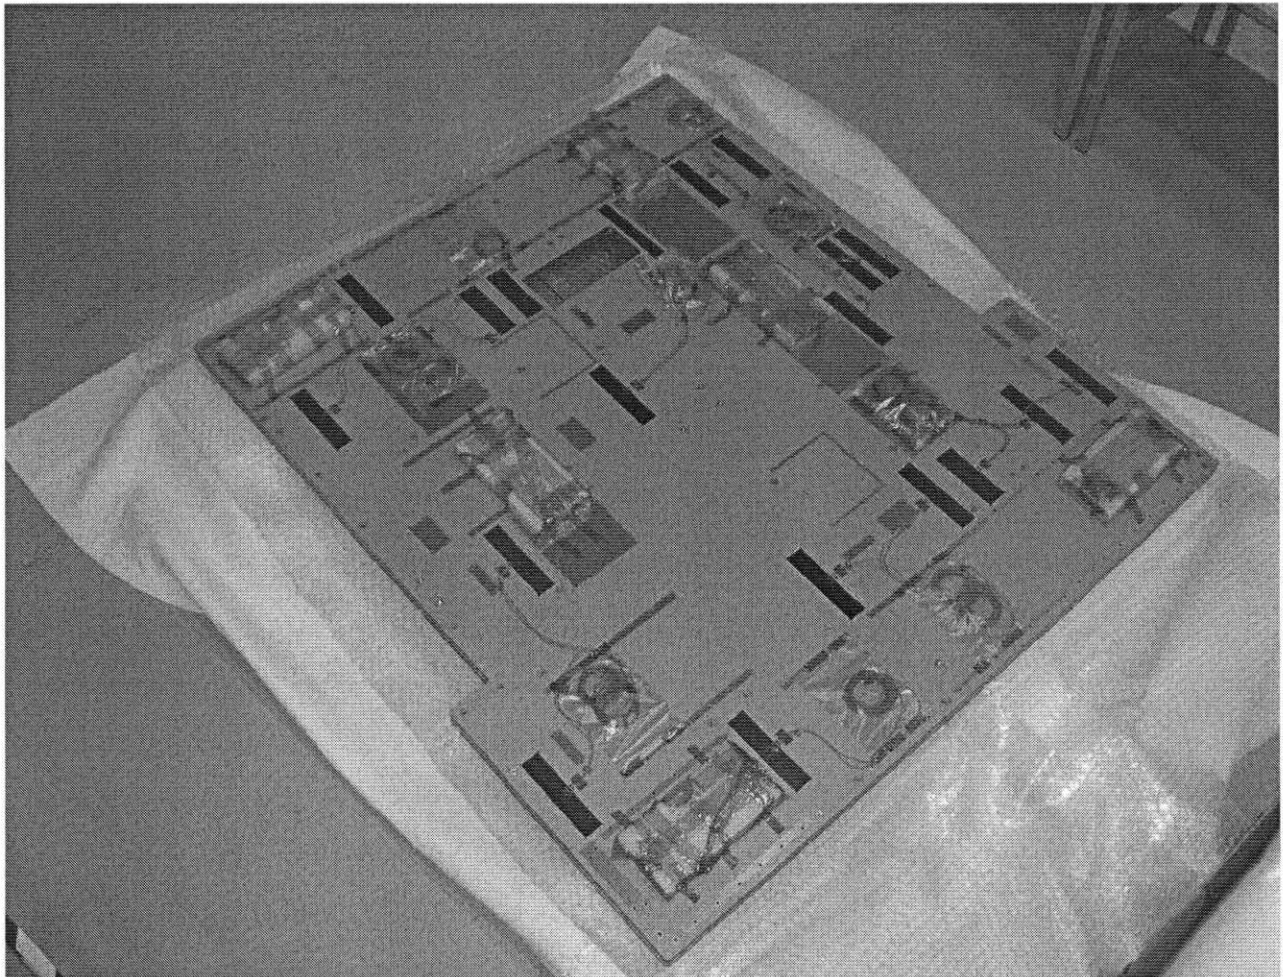
RAM RADIATOR 21-AMS-000.00.00 **RADIATOR CRATES SIDE**

1) The item structure has been found :

- a) Free of dust and other particles**
 - b) Free from finger-prints**
 - c) Presence of some adhesives and of greasy remains has been noticed. Some stains and spots can be noticed on the surface. Final cleaning is required.**
 - d) No scratches or deformation and cracks have been noticed**
- The reworked area , is shown in the picture below.**

Apart from the four injection holes no trace of damages has been noticed.

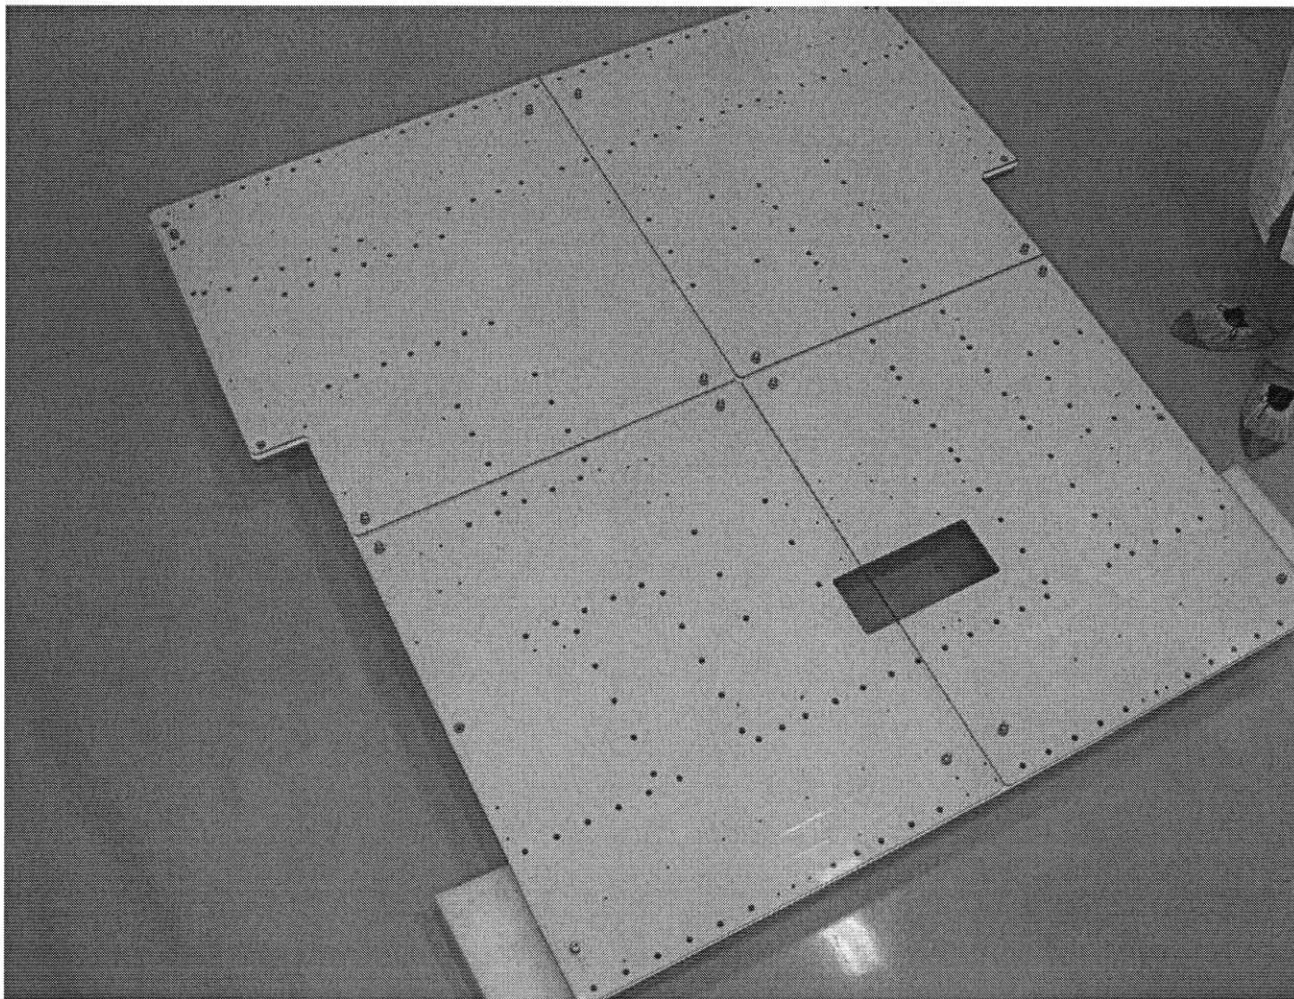
RADIATIVE SIDE

1) The item structure has been found with protection shields installed ; the following has been noticed :

- a) Free of dust and other particles**
- b) Free from finger-prints**
- c) No scratches or deformation and cracks have been noticed**
- d) No visible corrosion or moisture have been noticed**
- e) The Paint SG121FD results to be uniformly applied and there were no release of visible particles. . It results rough at the contact.**

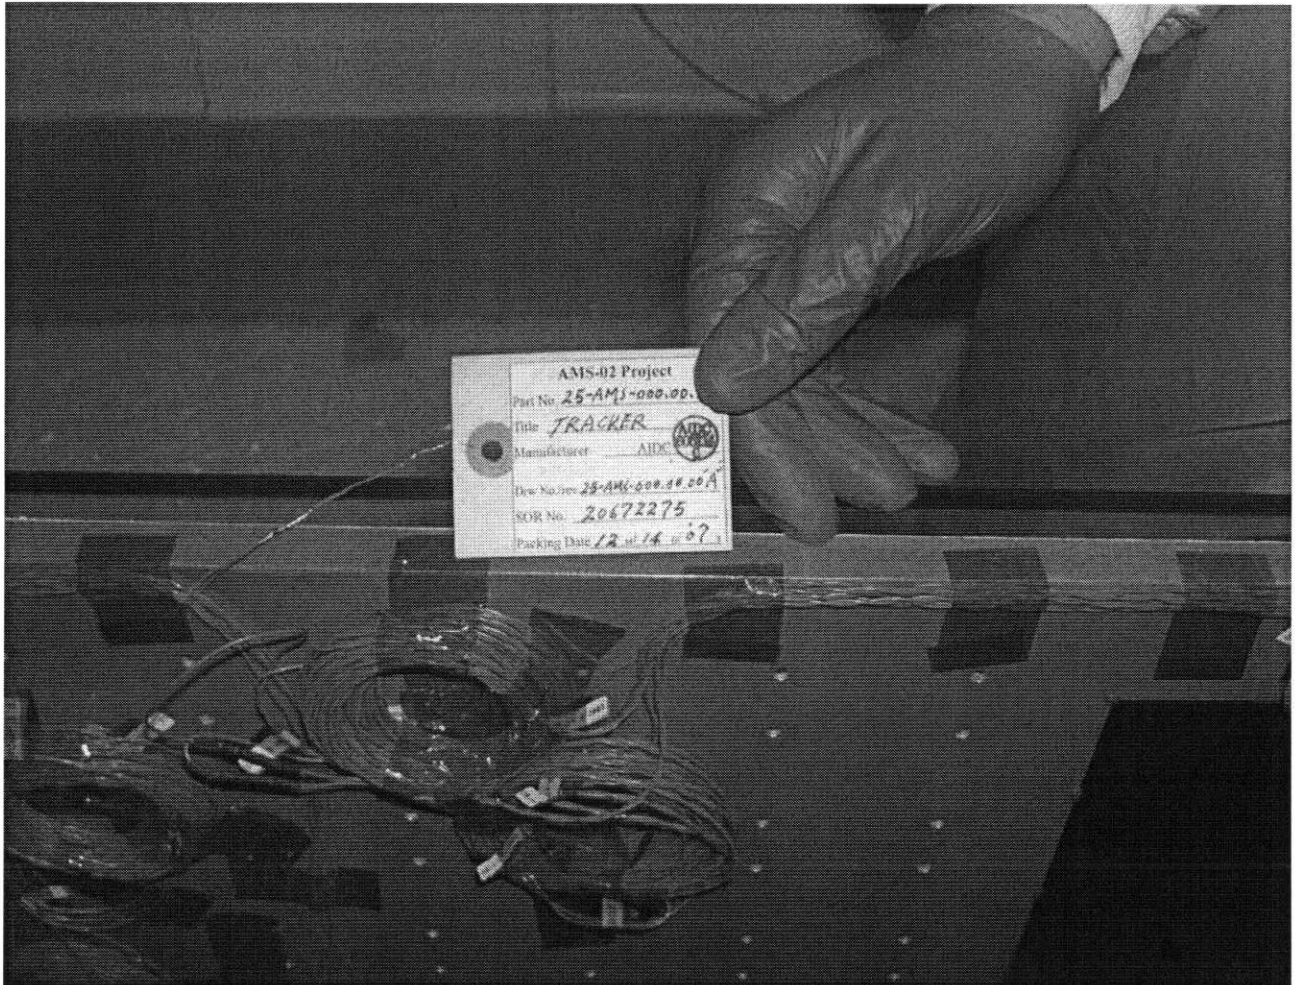
- b) AIDC Identification number 20672275 (CGS S/N 01). The identification label was attached with a metal wire at one shield fixing screw.**

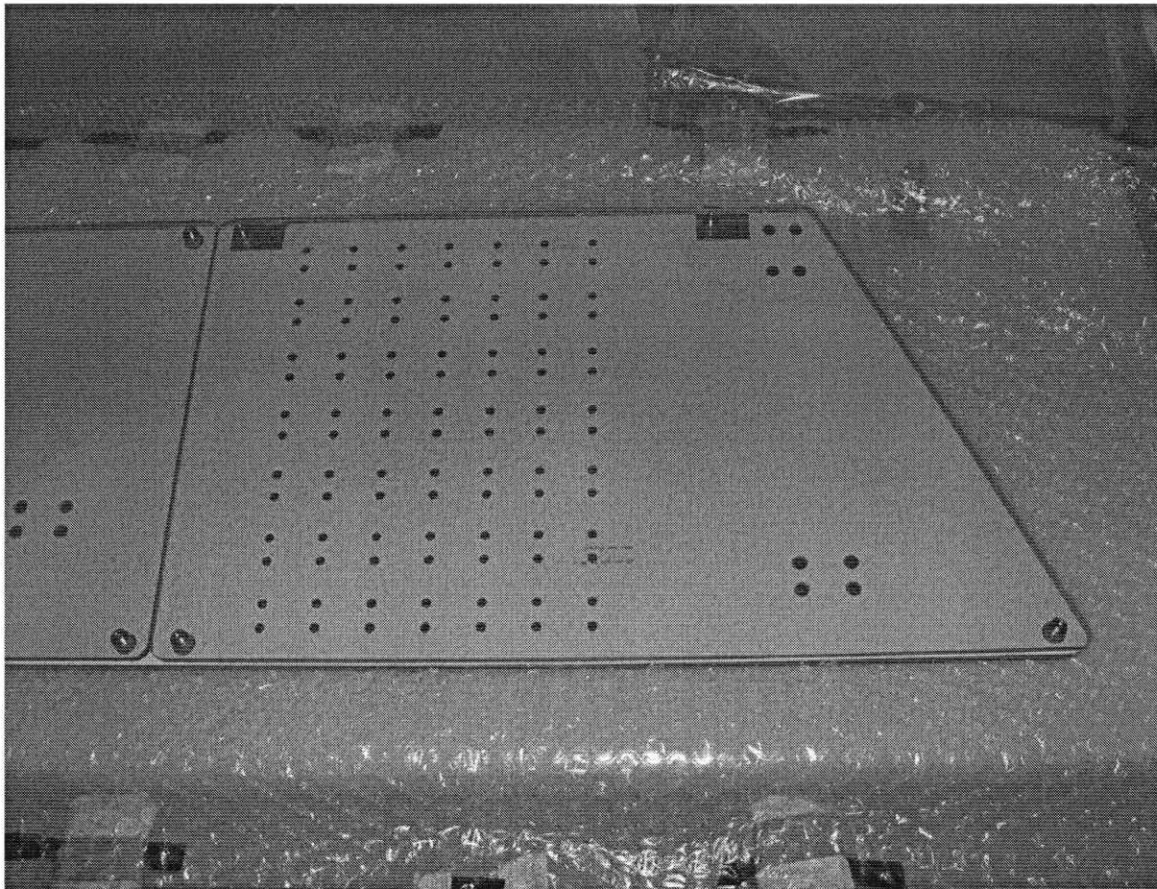
RADIATIVE SIDE

- 1) *The item structure has been found with protection shields installed ; the following has been noticed :*
- a) Free of dust and other particles*
 - b) Free from finger-prints*
 - c) No scratches or deformation and cracks have been noticed*
 - d) No visible corrosion or moisture have been noticed*
 - e) The Paint SG121FD results to be uniformly applied and there were no release of visible particles.*
